Ace Inspectors
 Tx License 8796
 208 Montego Bay
 El Paso, Tx 79912
 Tel (195) 539 3096

Date: 26 Jan 06 Week 04
 Time: 12:45 p.m.
 Temp. 69° F
 Weather: Good - 28% rel. hum.

Site Report No. **Client 26 Jan 06**
 Owner: Client's Name
 Address: Client's Address
 Report By: Inspector's Name

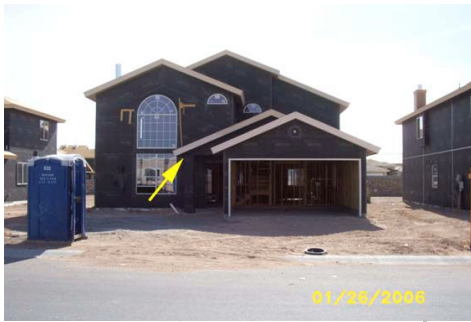
Looking south @ front of house – note arrow indicates missing stucco lathe (mesh) **1**

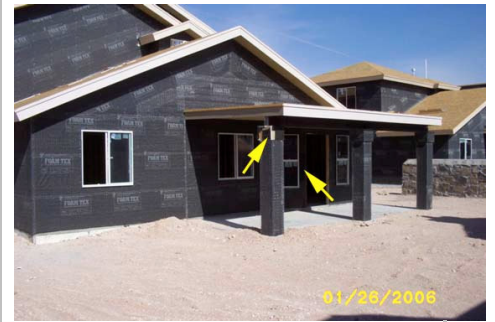
Looking north east @ rear of house – arrows indicate missing column caps and indicates missing stucco lathe **3**

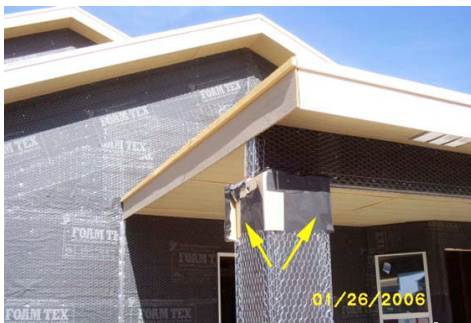
Looking north east @ close up of missing column caps **4**

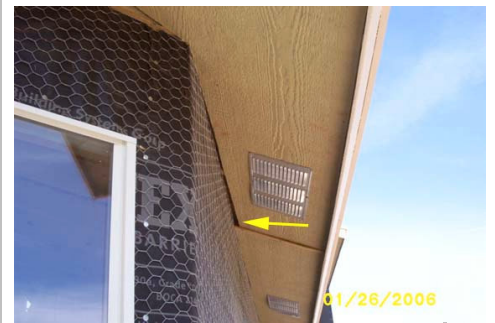
Looking north @ gap along east side soffit **6**

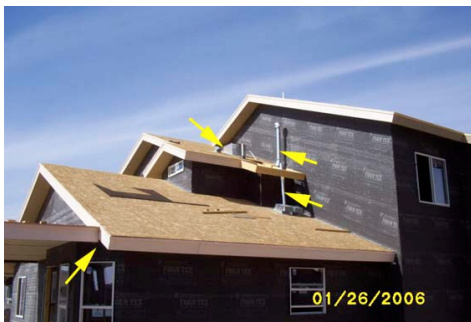
Looking @ south east corner of house – furnace and water heater flues too short and too close to vents and AC **7**

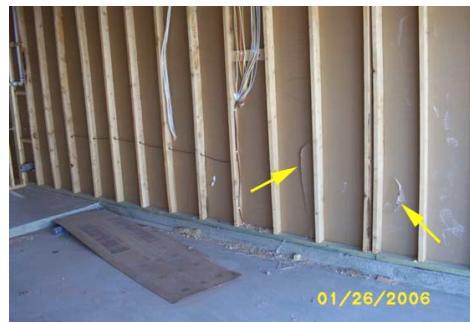
Looking southwest @ garage interior west wall (exterior) sheet rock damage **8**

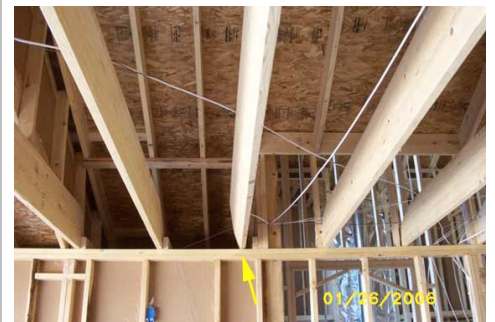
Looking east @ garage interior east side – note arrow points to severe twisting ceiling joist **9**

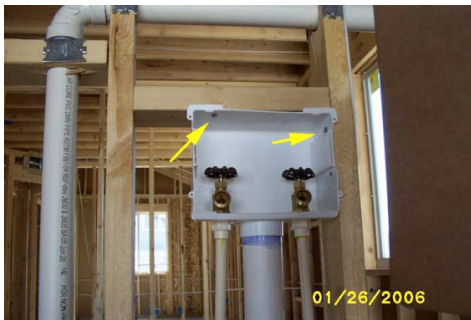
Looking @ washer hook up box – note nails used to anchor in place **10**

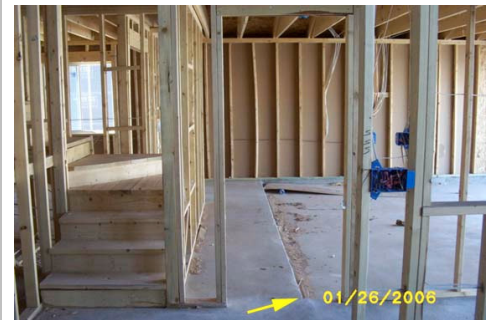
Looking @ door leading to garage – note garage step down bisects pathway in and out of door **12**
