I. STRUCTURAL SYSTEMS

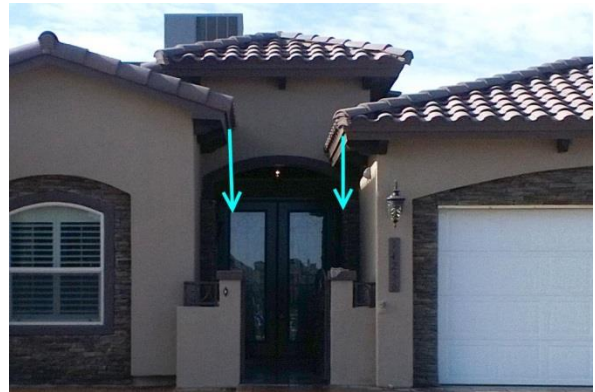
1. The Overall Grading & Drainage is acceptable
2. Note – Properly installed Gutters and Down Spouts can greatly help in managing drainage the roof surfaces draining into the front entrance (see picture)
3. Note – The flat roof scuppers will pose a challenge on the east side of the house

1. The Front Entrance is in good condition, however seen Section IB (Grading and Drainage) for the need of gutters to control water runoff into the front entrance area
2. The Rear Patio is in good condition, however the three post bases should be monitored for eventual water affects

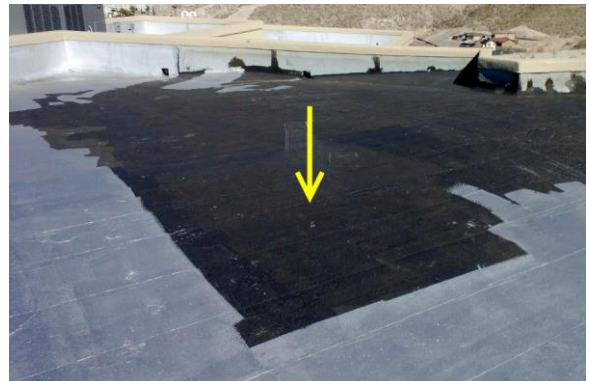
1. *Deficient – The Main Flat Roof section is not finished – Aluminized Elastomeric Coating is not fully applied (see picture)

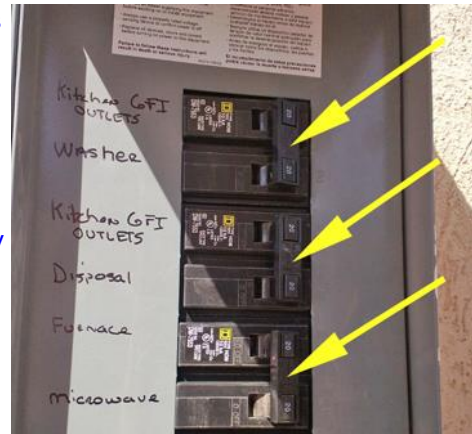
1. The Main Electrical Service input is a "Below Ground" Feed – The Service Wire is Copper – The Service Voltage is 120/240 volts - 125 ampere service
2. The Electrical Service is an Integrated Service and Breaker Panel
3. The Location of the Panel – Mounted to the south exterior wall
4. Observation – Both grounding electrodes are present
5. Observation - AFCI Breaker protection is present for the family rooms, dining rooms, living rooms, den, bedrooms, closets and hallways
6. *Deficient - The six individual circuits are tied together as though they are 220v circuits (see picture)

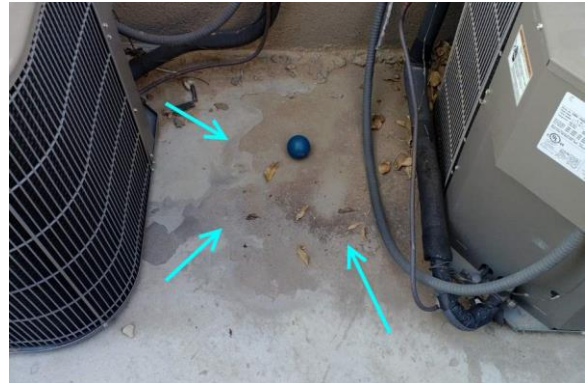
1. There are Two Refrigerated Air Cooling Units
2. The Refrigerated Air Cooling coils (evaporators) are located in the same utility closets as the furnaces
3. The Cooling Unit Condensers are located on the north side of the side of the house next to the north gate
4. The Cooling Units were inspected (seasonally shutdown - not operated) and appear to be acceptable
5. Observation – The Cooling Units are controlled by the same thermostats used by the furnaces
6. Observation – The Cooling Unit is controlled by the same thermostat used by the furnace
7. Observation - The Cooling Unit Condensate line terminates out the west wall of the garage
8. *Deficient – The Cooling Unit Condensate lines terminate onto the condenser pad – because the pad has a negative slope, the condensate is degrading the pad (see picture)

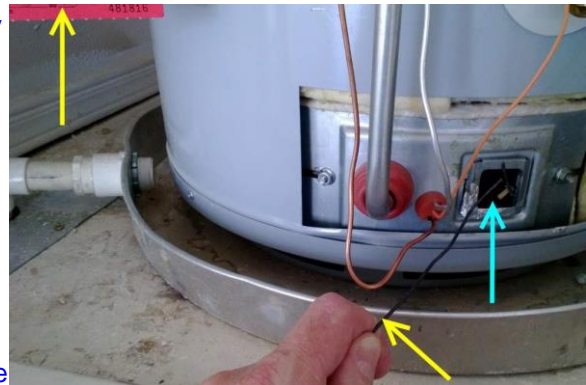
6. The Water Heater was operated / inspected and found deficient (see below)
7. *Deficient - The water heater is not regenerating hot water properly
8. *Deficient - The water heater was found with a "Red Tag" from the gas company (3 April 2013) (see picture)

9. *Deficient - The site glass at the bottom of the tank is missing and the igniter button appears ineffective (see picture)
10. Observation - There is coat hanger within the closet that appears to have been recently used to light the unit (see picture)

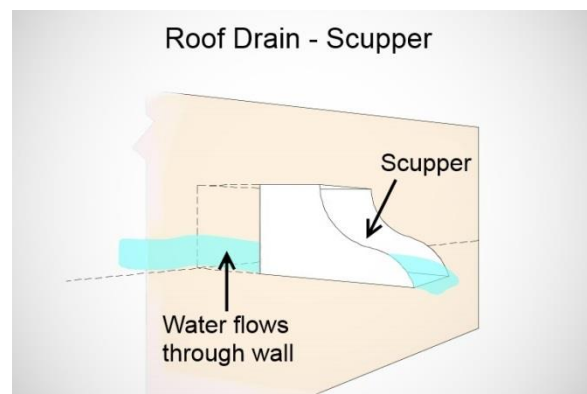
2. Note - Flat Roof Scuppers are used to transfer rainwater off flat roof surfaces. By design, water flows through walls by means of the scupper increasing the chances of water penetration into the roof structure and or wall structure. If every roof component interfacing with the scupper and the scupper itself is installed correctly, then only the lack of maintenance over time poses the risk of leakage into those structures.
